Manhole Inspection Summary

Manhole # S39WW_051MH

Insp Date: **12/18/06 1:58 PM**

Location Address: **825 MONTPELIER ST**

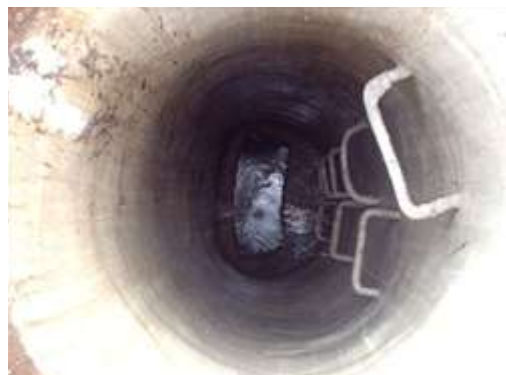
Top View

Frame leaks. Corbel infiltration. Bench debris.

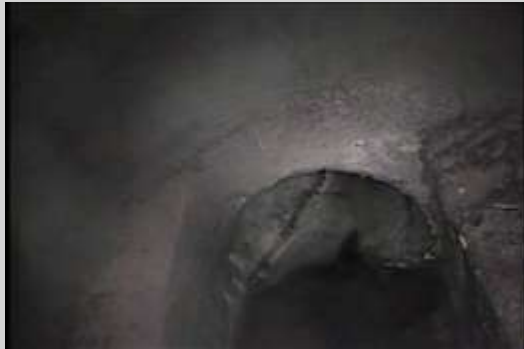
15 in. Circular Gravity Sewer Pipe Out @ 12 O'Clock

Rod and Bar (Angled)

Pipe Material: **Unknown** ☐ Pipe Lined

Invert Depth: **15.28** (ft.) Flow Characteristics: **Slow**

Deposits: ☒ None ☐ Mud ☐ Sludge ☐ Debris ☐ Grease

Infiltration: **None** Pipe Seal Cond: **Unknown**

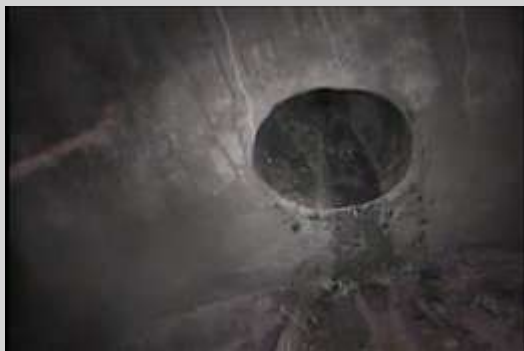
8 in. Circular Gravity Sewer Pipe In @ 3 O'Clock

Rod and Bar (Angled)

Pipe Material: **Clay** ☐ Pipe Lined

Invert Depth: **13.41** (ft.) Flow Characteristics: **Slow**

Deposits: ☒ None ☐ Mud ☐ Sludge ☐ Debris ☐ Grease

Infiltration: **None** Pipe Seal Cond: **Unknown**

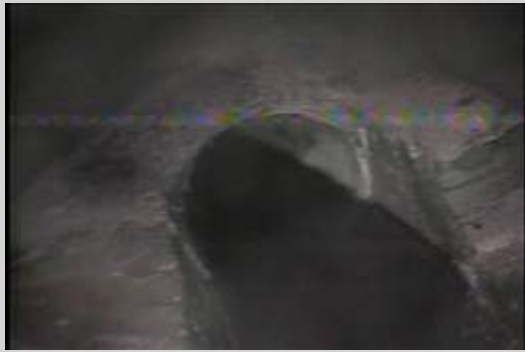
15 in. Circular Gravity Sewer

Rod and Bar (Angled)

Pipe Material: **Unknown**

☒ Pipe Lined

Invert Depth: **15.20** (ft.) Flow Characteristics: **Slow**

Deposits: ☒ None ☐ Mud ☐ Sludge ☐ Debris ☐ Grease

Infiltration: **None**

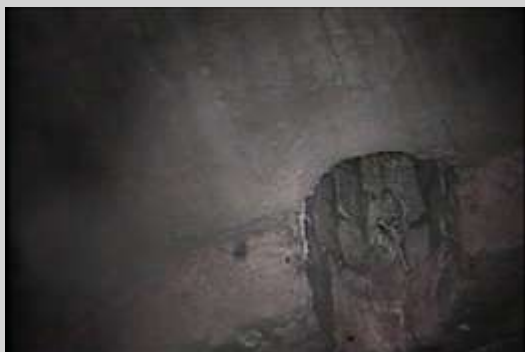
8 in. Circular Gravity Sewer

Rod and Bar (Angled)

Pipe Material: **Clay**

Invert Depth: **14.55** (ft.) Flow Characteristics: **Slow**

Deposits: ☒ None ☐ Mud ☐ Sludge ☐ Debris ☐ Grease

Infiltration: **None**
